ENVIRONMENT IMPACT ASSESSMENT & EMP REPORT FOR

“TSOMGO PASSENGER ROPEWAY”

NOVEMBER 2015

AT
TSOMGO LAKE, DISTRICT EAST OF SIKKIM, SIKKIM

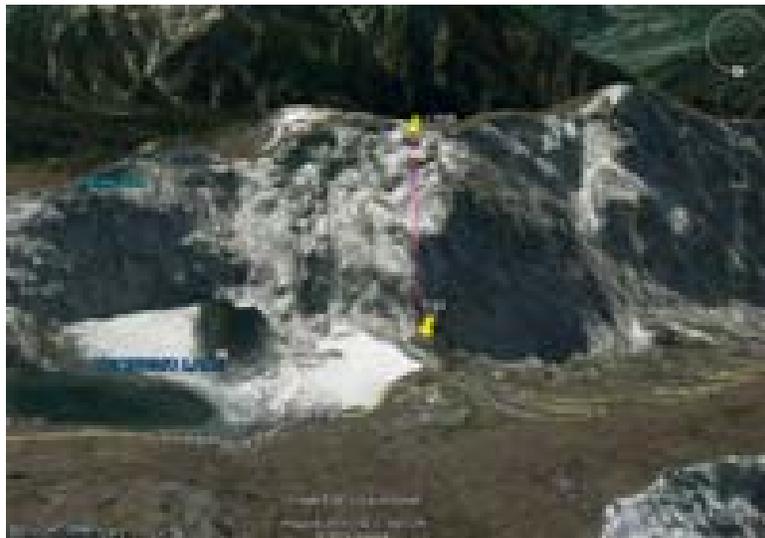
FIGURE 3-1 SELECTED ALIGNMENT

The selected site was the most stable stretch, requiring less construction works for flattening of land and no tree cutting was required. The total length of proposed ropeway alignment works out to be 625 m. the selected ropeway alignment is shown in figure 3-1.

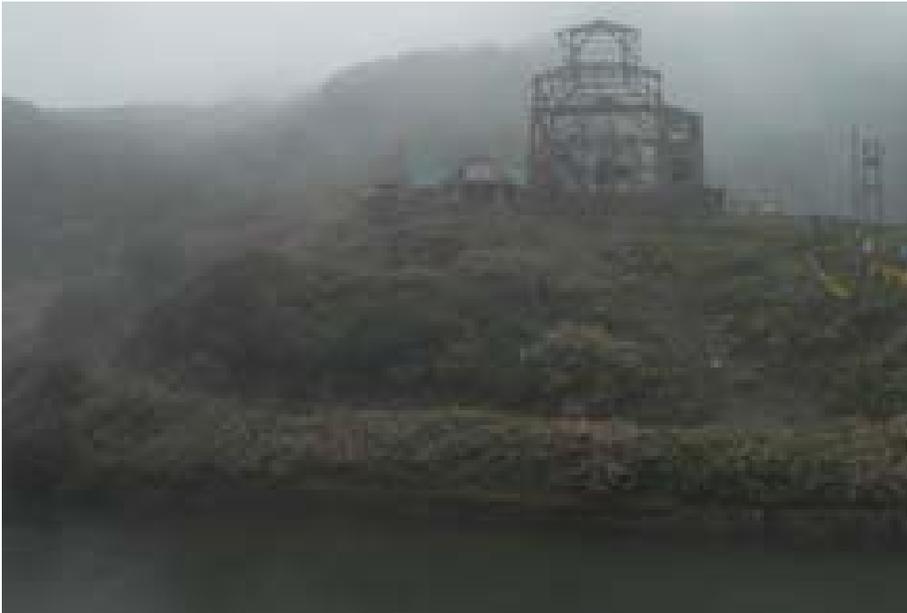
FIGURE 3-2: LTP

The LTP is developed east to the Alpine café (figure 3-2) and the area adjoining the motorable road was found most suitable for the following advantages:-

- Sufficient land was available for housing the station
- The site is easily accessible & close to the Main Road.
- Some infrastructure like refreshment kiosks, snack bar, etc. can be facilitated at this location

As per the survey, the site selected for the ropeway was found to be most suitable as the LTP was found to be easily accessible being near to Alpine Café, no major clearance of herbs & shrubs was required for the corridor and flat land was available on hill top for UTP.

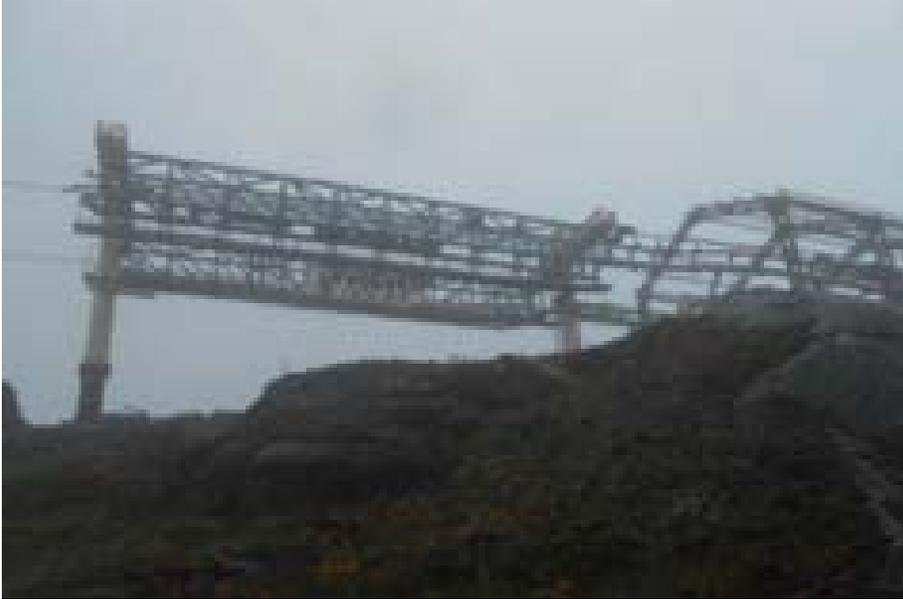
FIGURE 3-3: UTP

The UTP is developed at the hill top south to the lake (figure 3-3). It was found to be most suitable for the following advantages:-

- A good aerial view of the lake can be relished.
- A panoramic view of the snowcapped mountains around can be enjoyed.

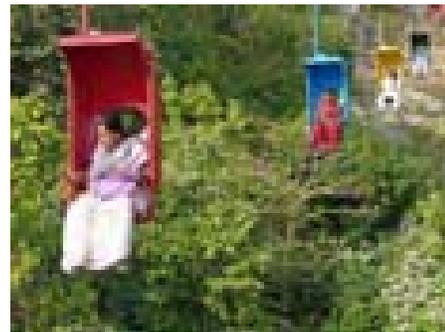
It is a monocable endless system. One continuously circulating rope serves the dual purpose of supporting as well as hauling the chairs clamped to the moving rope at specific intervals. In between the terminals, the rope is supported on sheaves mounted on towers.

The most common on Chair Lift system are the Twin Seater Chair Cars. With more modern developments, Chair Lifts with cars for 3, 4, or 6 passengers have also come in use. They normally have detachable type Grip, whereas the ones with twin passenger chairs have mostly Fixed type Grips.

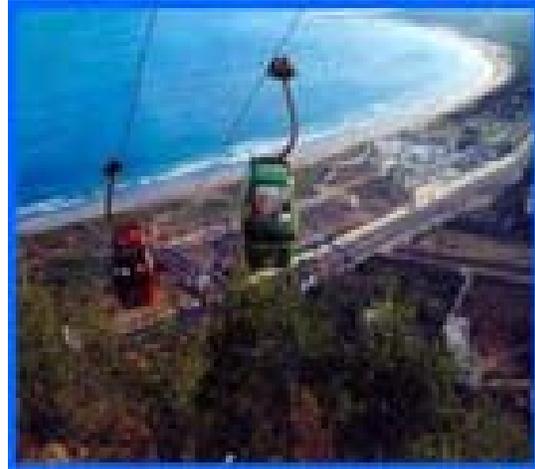
A Mono-cable Ropeway System comprises basically an endless rope which acts both as the carrying as well as the haulage rope to which a number of carriages are attached at regular intervals. The carriages circulate around the close system by continuous carrying-cum-haulage rope. The cabins are fully enclosed and because of this fact, the passengers inside, feel quite comfortable, even if the cabin travels at a considerable height from the ground profile. Usually the carrying capacity of each carrier varies from 2 to 8 passengers.

Mono-cable can either be fixed grip or detachable grip. Fixed grip ones can be either normal fixed grip with chairs, cabins suspended at regular intervals along the line or pulsed, in which case, a group of cabins are placed at regular intervals.

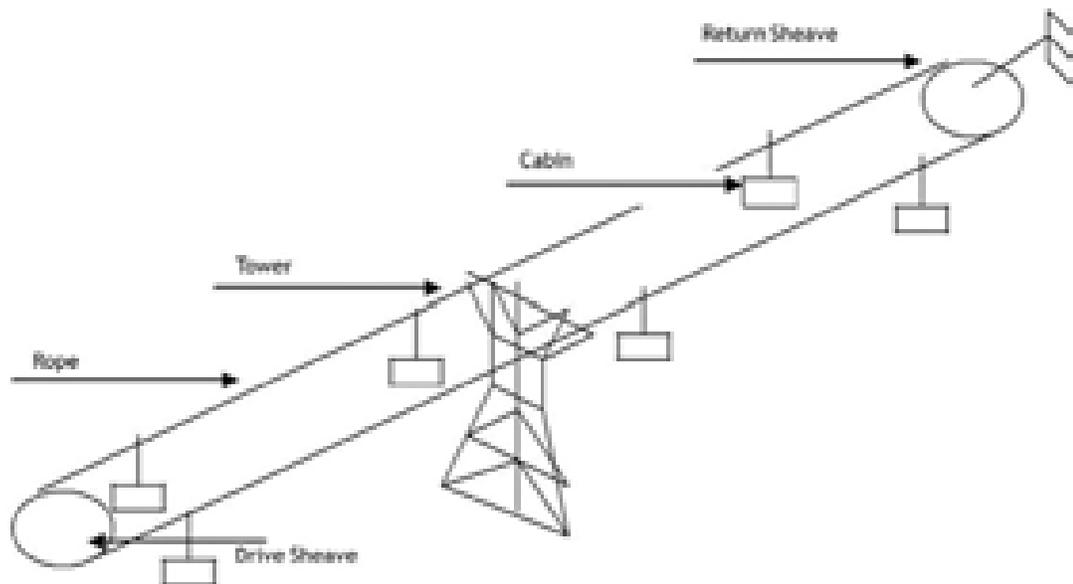
FIGURE 3-4 MONO-CABLE CONTINUOUSLY CIRCULATING GONDOLA SYSTEM

A pictorial view of such type of Gondola system is shown in figure 3-3.

3.4.1 System description

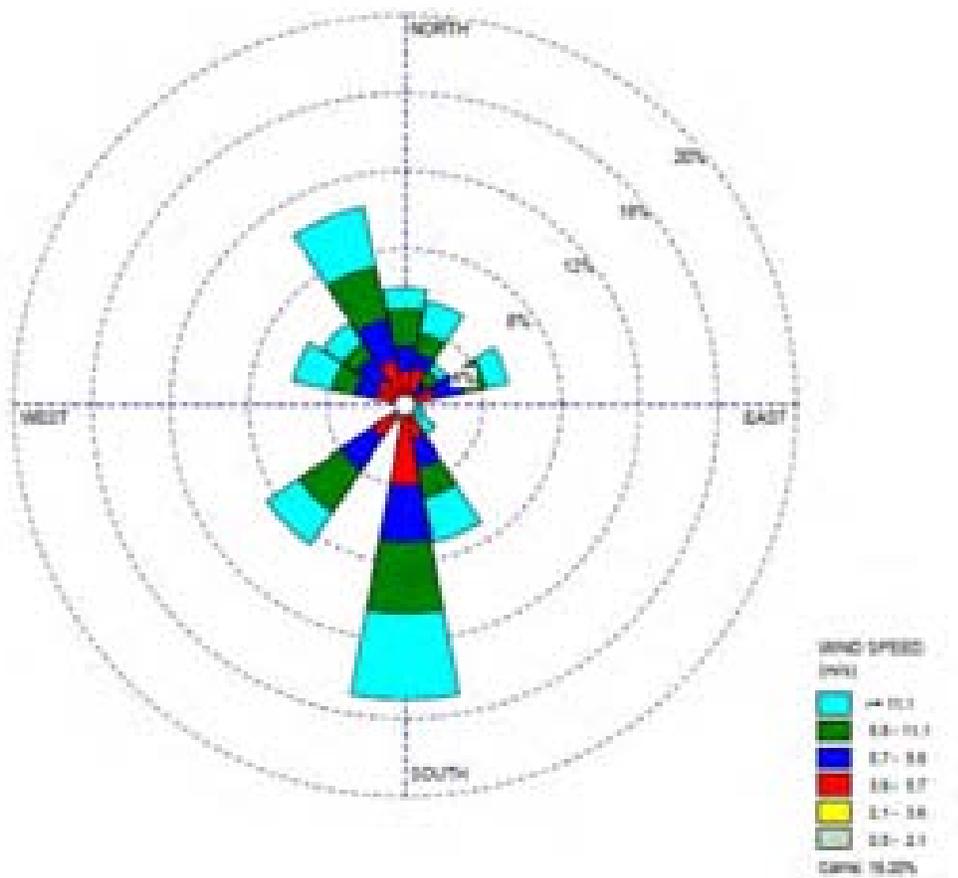
FIGURE 4-1; SEASONAL WIND ROSE DIAGRAM

- i) **Temperature:** Temperature of the area varied from 1.0 °C to 28.0 °C. The Average temperature varied from 12.0°C to 19.0 °C.
- ii) **Relative Humidity:** Humidity of the area varied from 10.0 % to 94.0%. The average humidity varied from 24.0 % to 25.0 %.
- iii) **Wind Speed:** Wind speed was in the range of 1.9 Km/hr to 29.0 Km/hr. The wind speed was almost close to each other during the whole study period. The average wind speed varied from 13.0 Km/hr to 16.0 Km/hr.

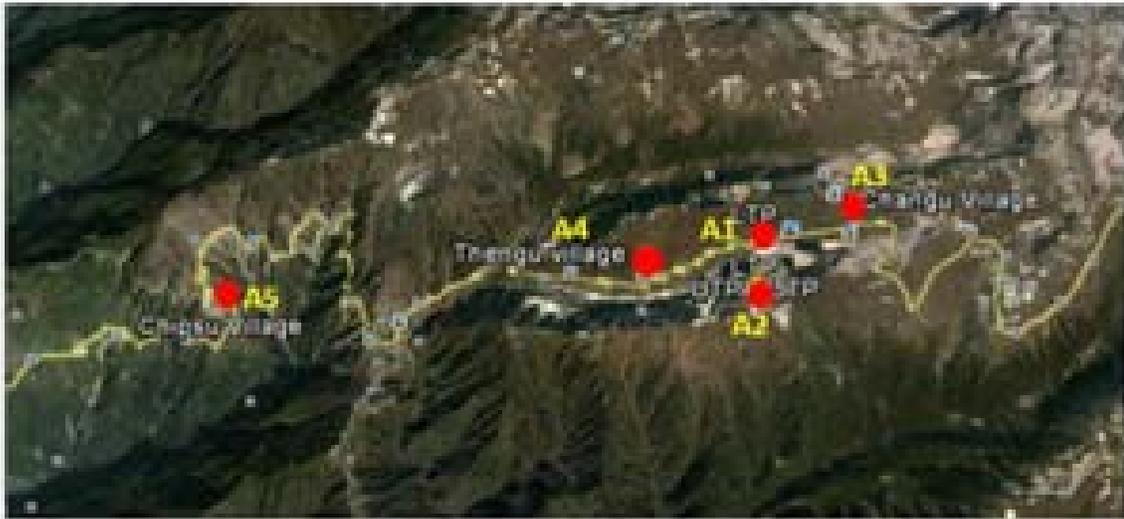
FIGURE 4-2; AMBIENT AIR SAMPLING LOCATIONS ON 10 KM GOOGLE MAP

To select the air sampling locations, meteorological data with respect to temperature, relative humidity, wind speed and direction plays a vital role. Predominant wind direction plays an important role in determining location of monitoring stations. The monitoring station will be located in area that is downwind from the source. Location of Air sampling stations is shown below.

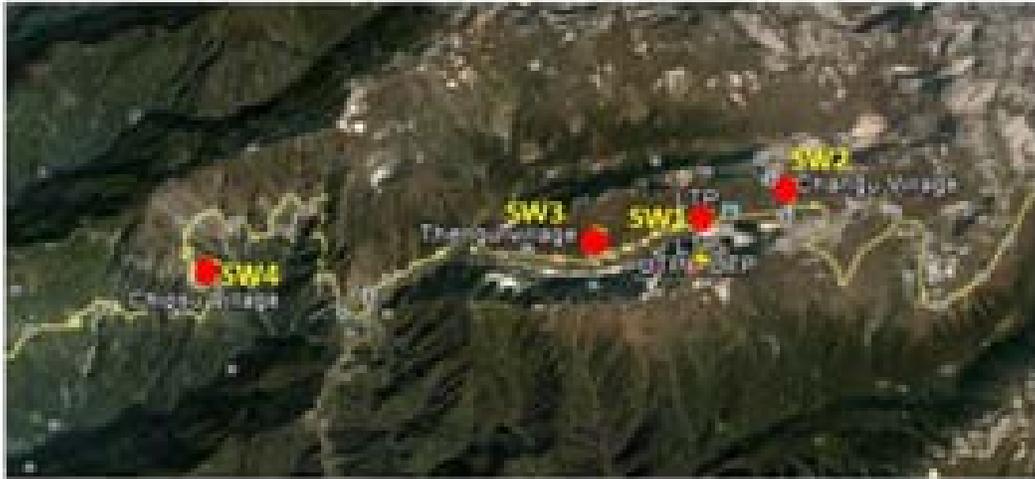
FIGURE 4-4; WATER SAMPLING LOCATIONS ON 10 KM GOOGLE MAP

Surface water was collected from Lake to study the chemical parameters. During surface water sampling flow of water plays an important role.

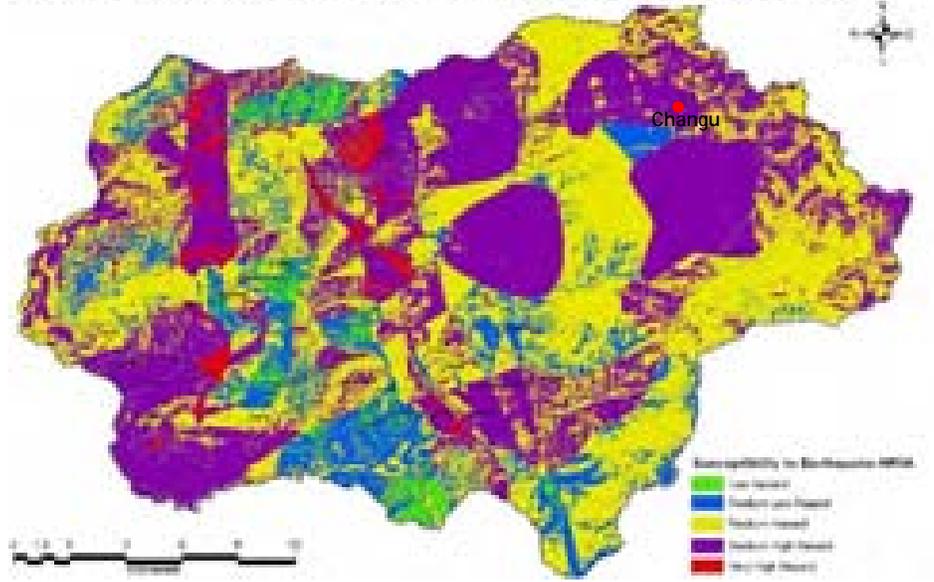
SUSCEPTIBILITY/VULNERABILITY TO EARTHQUAKE HAZARD MAP OF EAST DISTRICT

As per fig. 7- 2 and as per National Disaster Management Authority's database, the project site is located in (East Sikkim) seismic zone IV which indicates high damage risk zone.

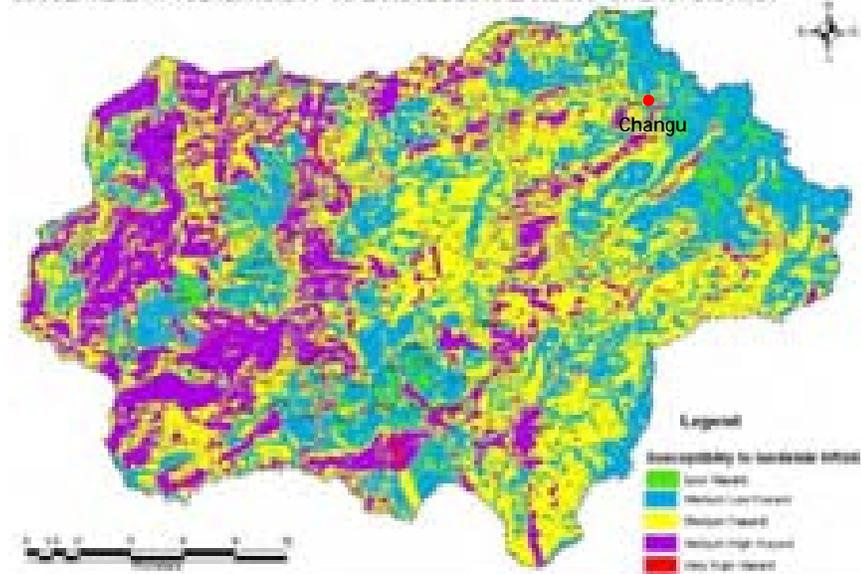
FIGURE 7-3 LANDSLIDES MAP OF EAST SIKKIM (SOURCE- SSDMA)

As per the Physiography, topography & terrain of the area and the landslide hazard map of East Sikkim shown in fig. 7-3, the area is medium to high prone to Landslides.

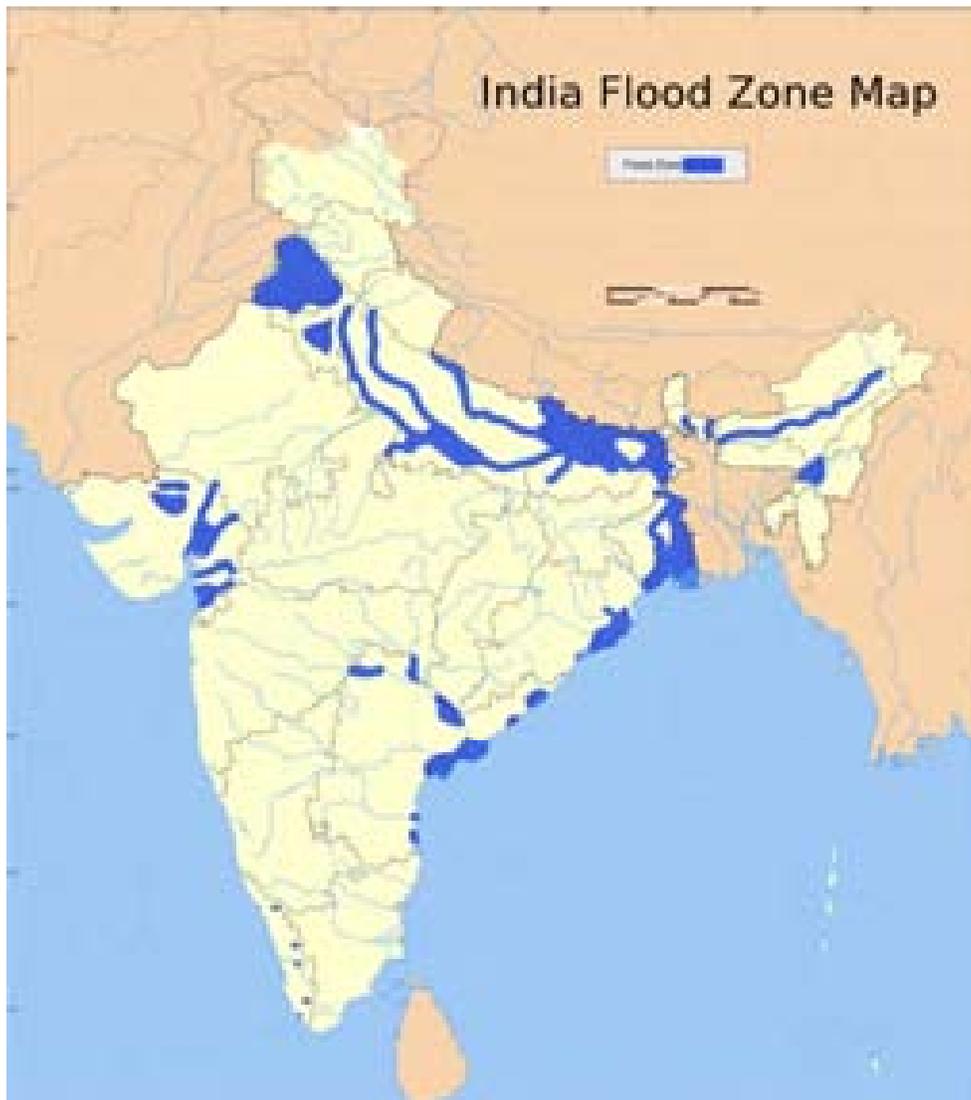
Figure 7-4 Flood map of India

As per Flood Hazard map of India given in fig. 7-4 & topography of the project, the site falls under medium flood prone area.

The project is installed near Changu Lake which itself could be a source of flood in the region.

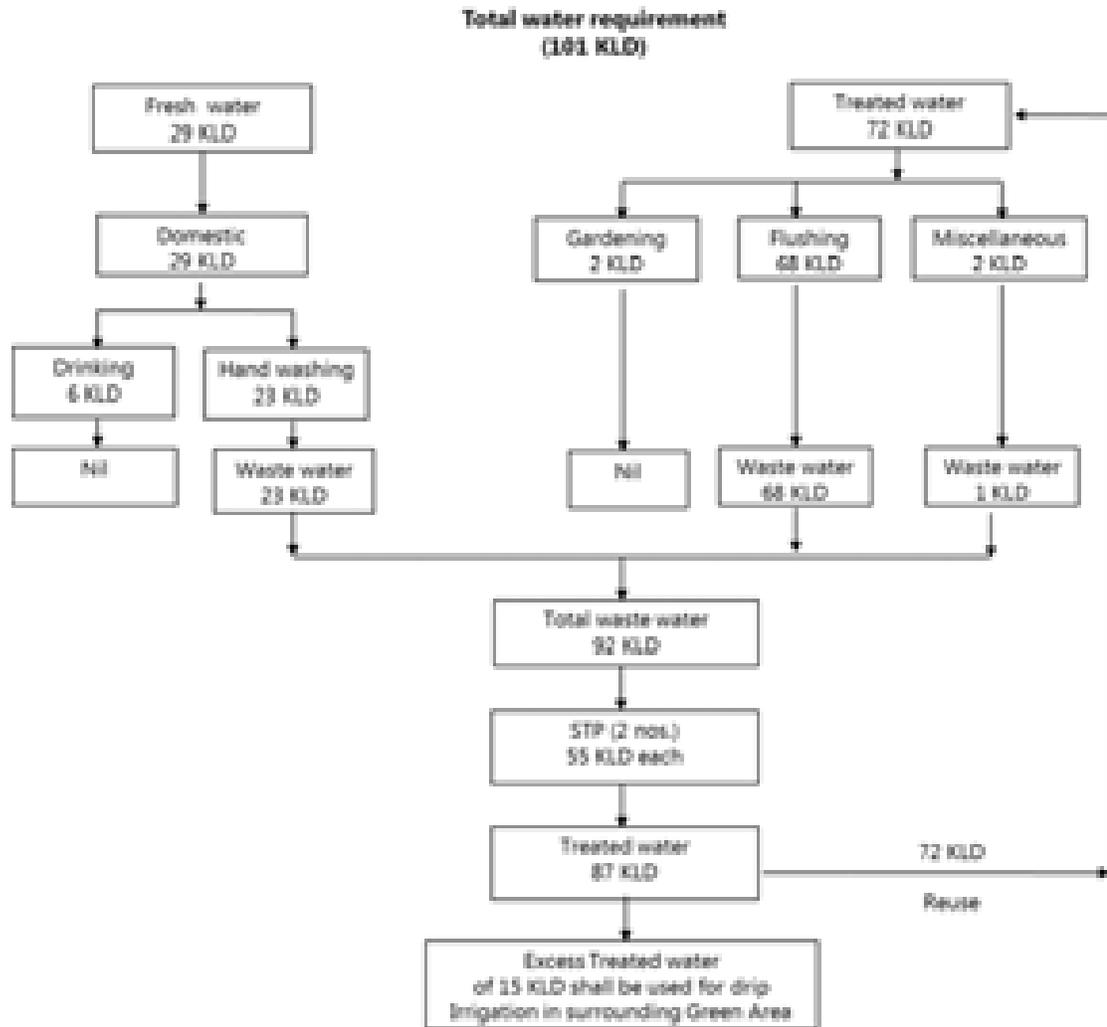
FIGURE 9-1 WATER BALANCE

The generation of total waste water will be about 92 KLD which will be treated in total 2 Sewage Treatment Plants (STPs) of 55 KLD capacities each based on FAB (Fluidized Aerobic Bio-reactor) process.

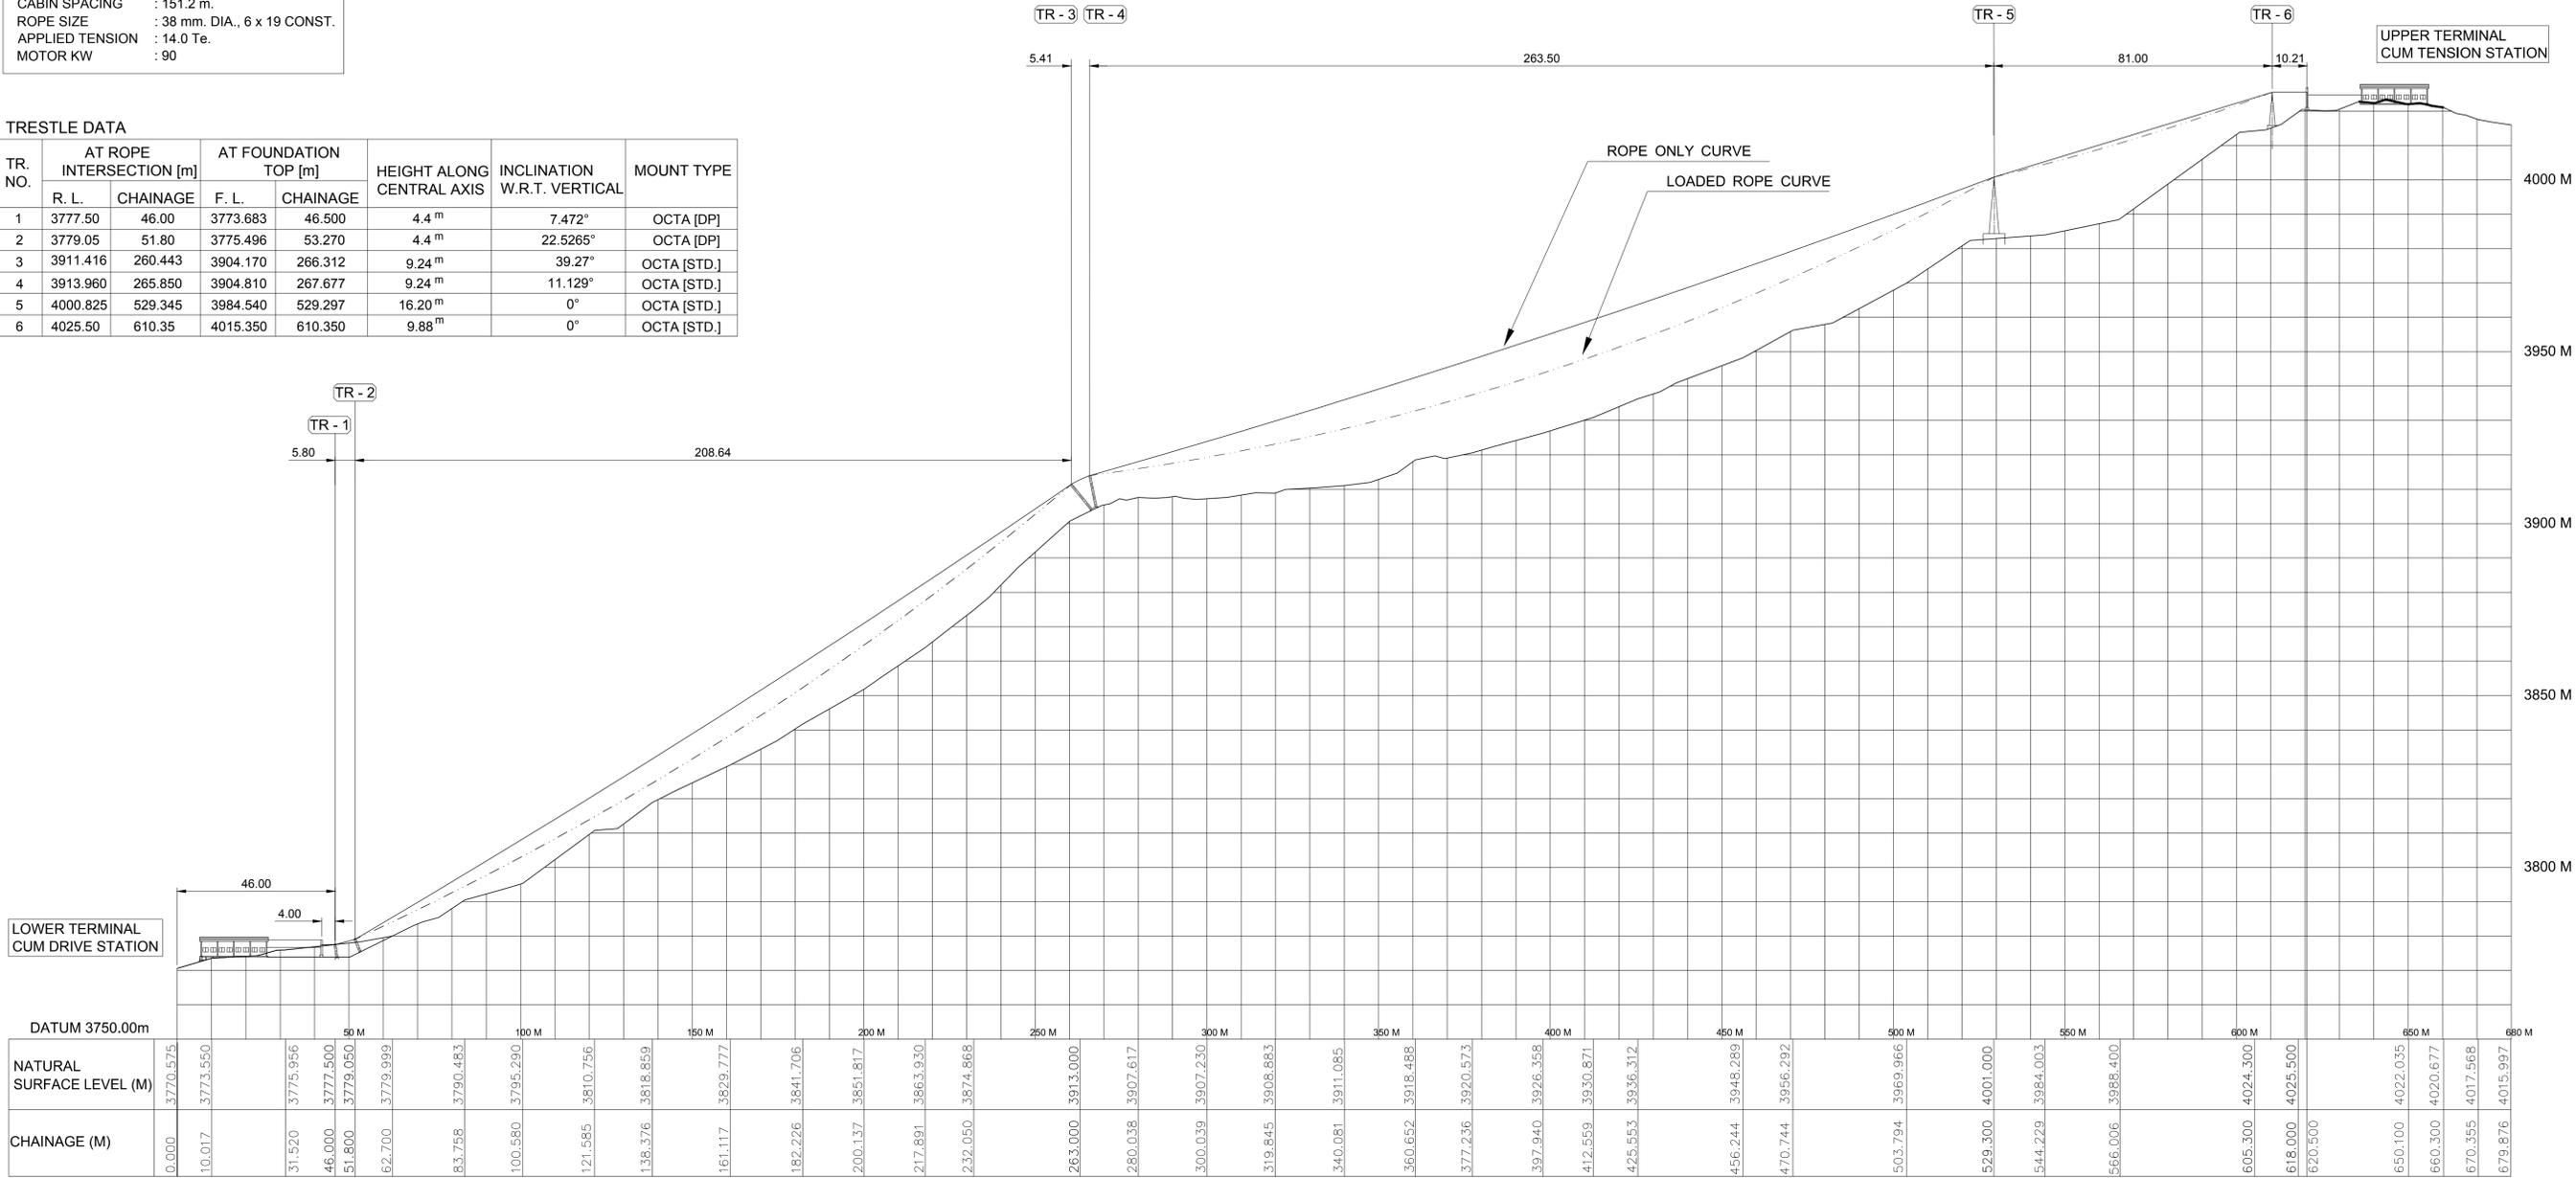
TR. NO.	AT ROPE INTERSECTION [m]		AT FOUNDATION TOP [m]		HEIGHT ALONG CENTRAL AXIS	INCLINATION W.R.T. VERTICAL	MOUNT TYPE
	R. L.	CHAINAGE	F. L.	CHAINAGE			
1	3777.50	46.00	3773.683	46.500	4.4 ^m	7.472°	OCTA [DP]
2	3779.05	51.80	3775.496	53.270	4.4 ^m	22.5265°	OCTA [DP]
3	3911.416	260.443	3904.170	266.312	9.24 ^m	39.27°	OCTA [STD.]
4	3913.960	265.850	3904.810	267.677	9.24 ^m	11.129°	OCTA [STD.]
5	4000.825	529.345	3984.540	529.297	16.20 ^m	0°	OCTA [STD.]
6	4025.50	610.35	4015.350	610.350	9.88 ^m	0°	OCTA [STD.]

DATUM 3750.00m	50 M	100 M	150 M	200 M	250 M	300 M	350 M	400 M	450 M	500 M	550 M	600 M	650 M	680 M
NATURAL SURFACE LEVEL (M)	3770.575	3773.550	3775.956	3777.500	3779.050	3779.999	3790.453	3795.290	3810.756	3818.859	3829.777	3841.706	3851.817	3863.930
CHAINAGE (M)	0.000	10.017	31.520	46.000	51.800	62.700	83.758	100.580	121.585	138.376	161.117	182.226	200.137	217.891
