IMPACT OF LANDSLIDE AND EROSION CONTROL TREATMENT

UNDER
TECHNOLOGY DEVELOPMENT EXTENSION & TRAINING PROJECT

WEST SIKKIM
2004-05 to 2008-09

Sponsored by
Ministry of Rural Development
Department of Land Resource

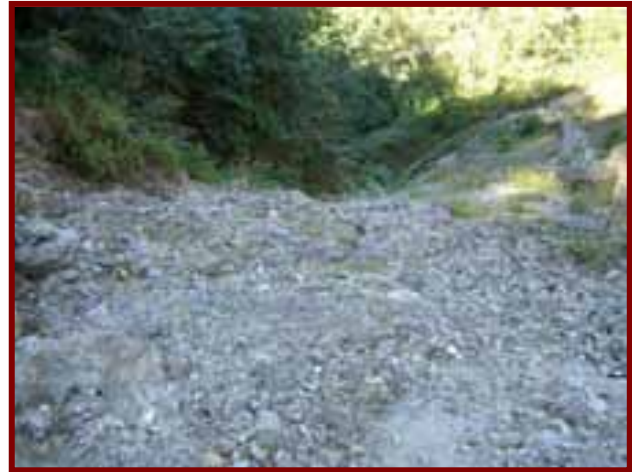
(Picture: Type of landslide in Pelling Naku Tadong)

1. The type of landslides in Pelling Naku Tadong were of slump and debris flow. The flow consisted of rapid mass movement in which loose soils, organic matter combine with entrained air and water to form slurry and then flows down slope. The flow mainly consisted of sandy soil mass of wet material that contains at least 50 percent sand-, silt-, and clay-sized particles, with viscous to fluid like motion of debris where the top soil had been completely washed away.

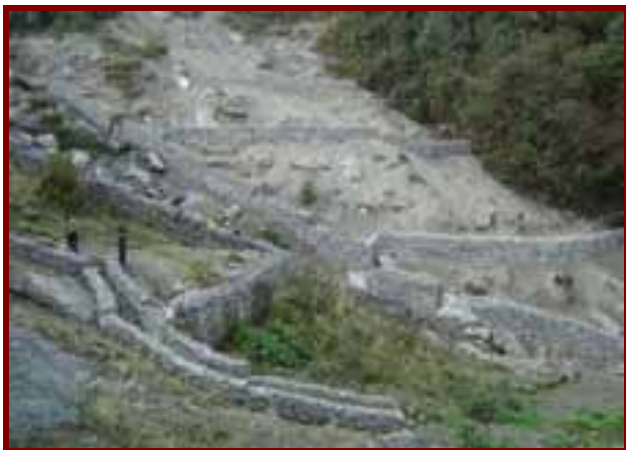
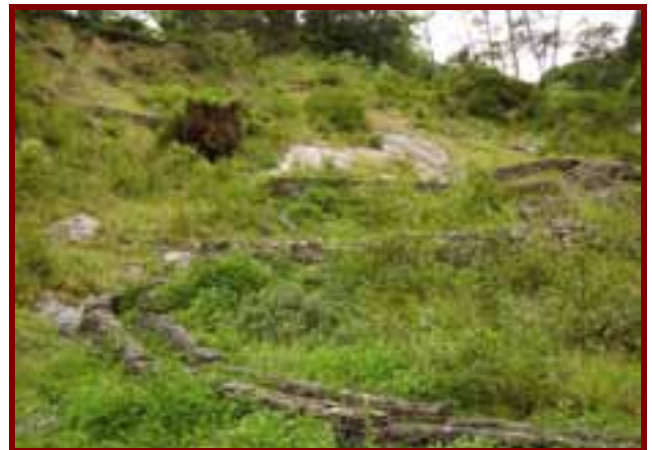
Before

After

1. Hands packed walls inside sausage guide walls have been made extensively all over the area to a large extent from the top of the slide to the base at regular interval along steep slopes. This has also been done along the perennial springs to prevent it from expanding.

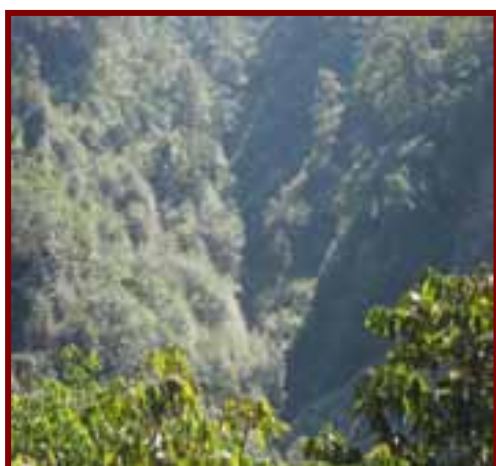
(Picture Below: Regenerated area from a distance)

The area previously was in a very bad shape, with irregular terrain and difficult topography.

The condition of slope at present has regenerated to a large extent. Complete forestation has taken place and is satisfying. Although the soil present here is micaceous and since no seepage of water takes place The seasonal springs continue to emerge and run haphazardly, but due to the hand packed walls inside GI sausage that is built, prevents the erosion the soil and does not allow erosion of the soil randomly.

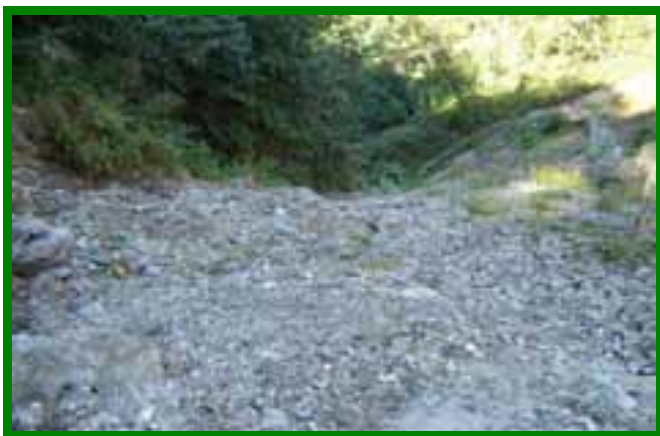
Rock-cum-debris flow

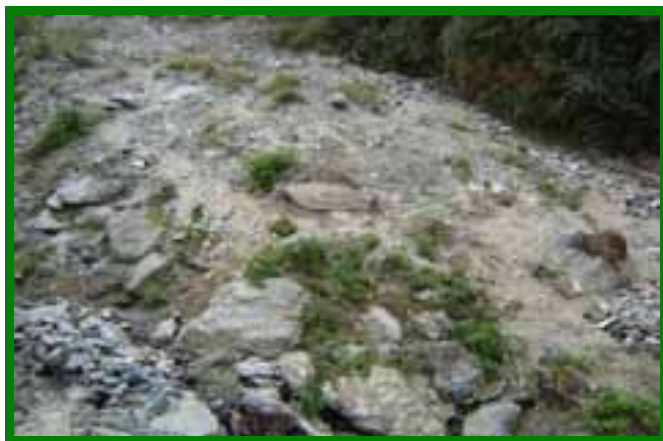
Status of the area in the beginning

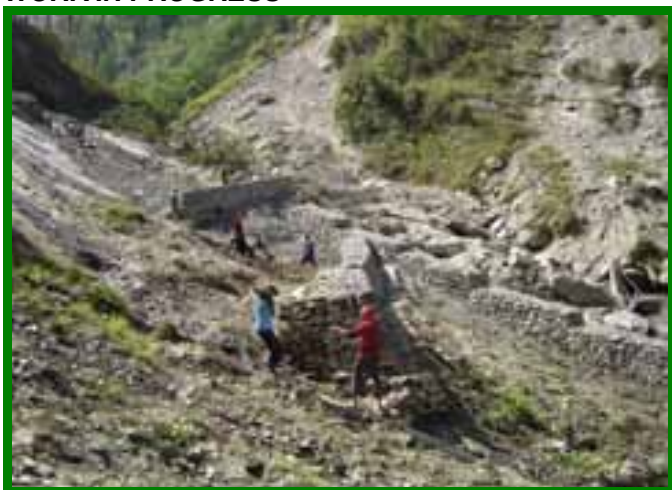
Hand packed stone wall inside sausage being built

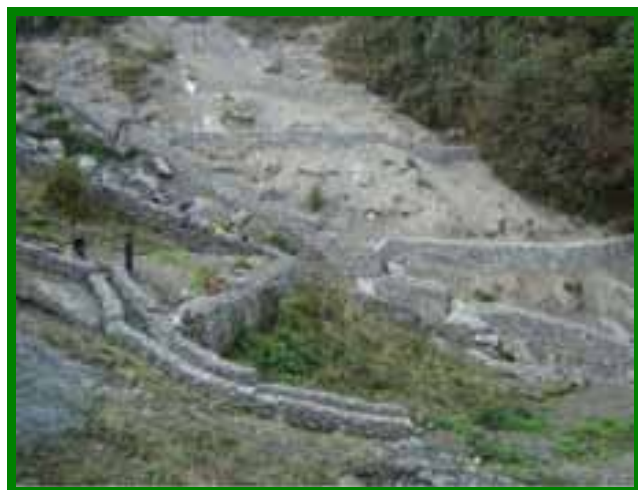
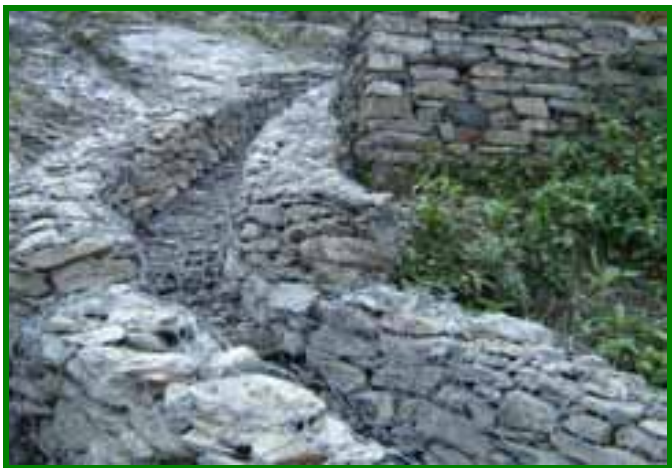
Drainage wall for the channeling of water

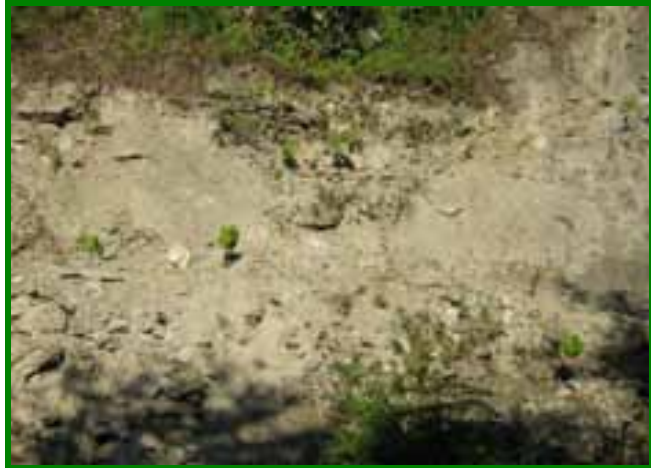
Plantation of saplings in eroded area

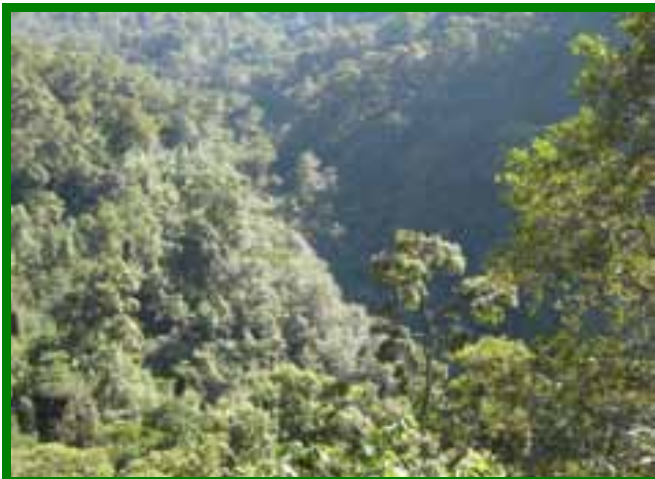
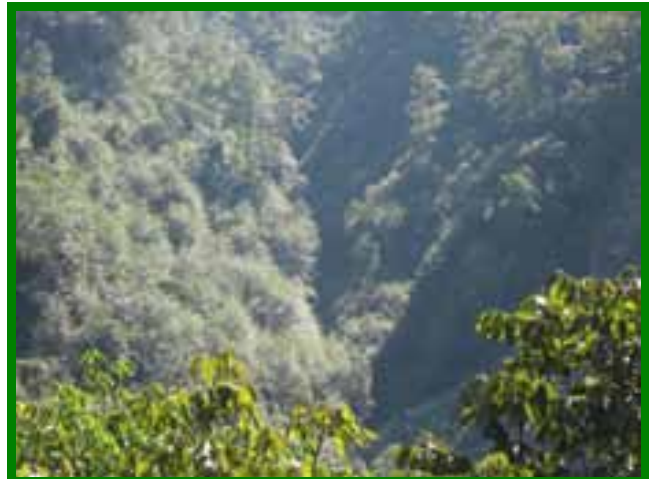
Regenerated area

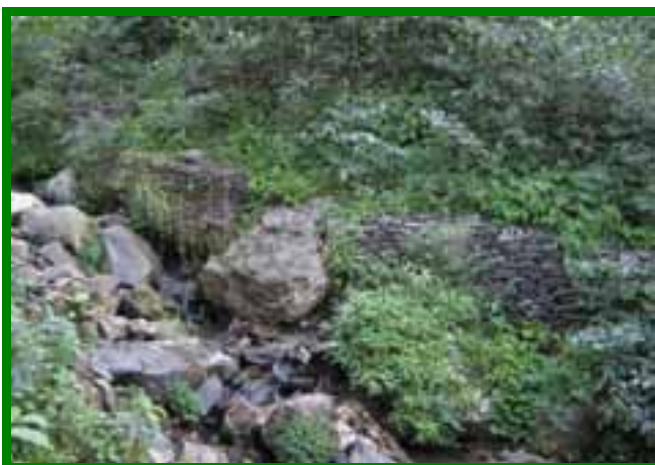
Growth of *Alnus nepalensis* around the Hand Packed wall

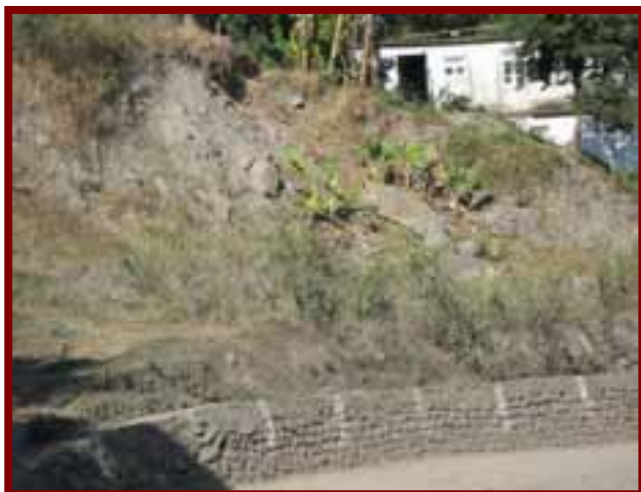
The area affected is Thapa Jhora which is surrounded by Sawaligaon on the north, Thapa Jhora Busty to the west and Pipalay bazaar to the east and river Rangit to south. This Jhora drains down to the river Rangit intersected by road that connects west district of Sikkim to the other districts. Erosion in these roadside areas creates a major problem in the transport system of the district as well as the state itself; cutting west Sikkim from the rest of the state.

(Picture: Landslide area treated with base structure)

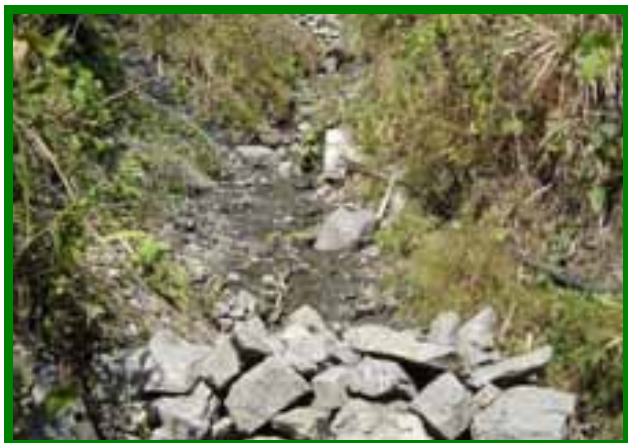
Steep slope aggravates rolling stones

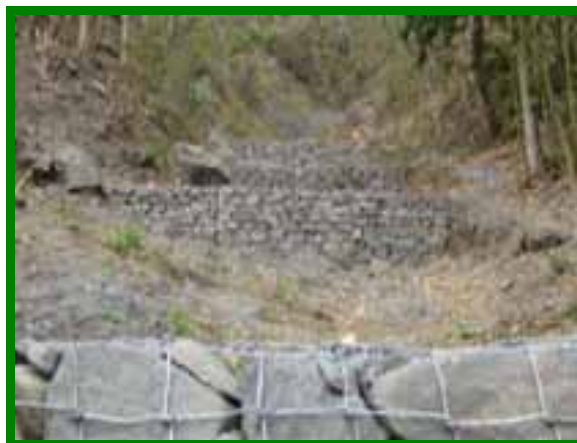
The same site brought under control with gabion structures strengthening site cuttings thereby improving natural regeneration

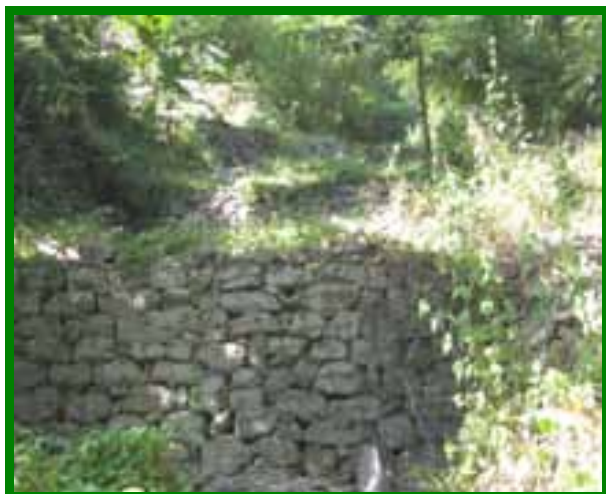
Series of sausage wall protected agricultural land and improved regeneration process

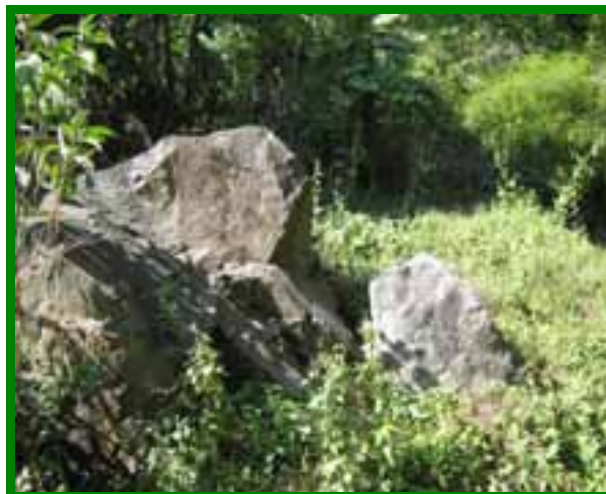
The same site fully stabilized now

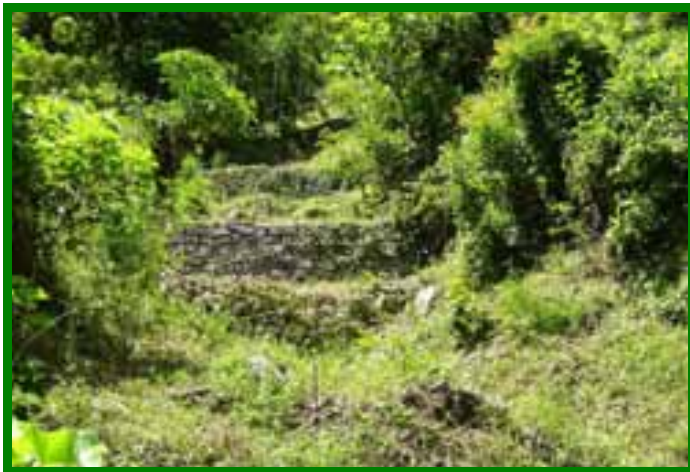
Faulty agricultural practice induced landslide and erosion; the sausage wall with Bio-engineering measures protected the agricultural land

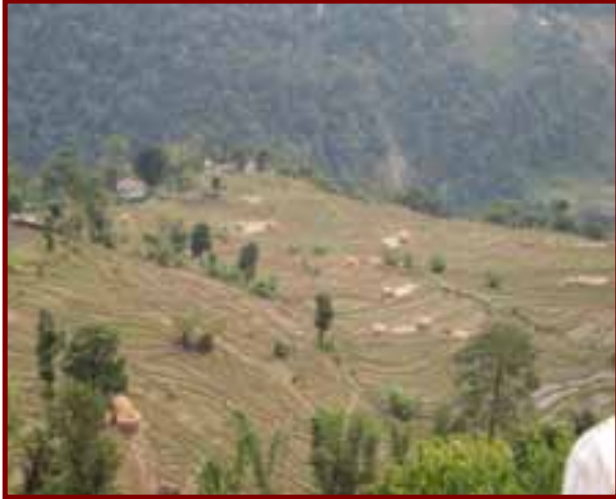
(The terrace lands frequently affected by fracture of land and cutting by Kalej Khola)

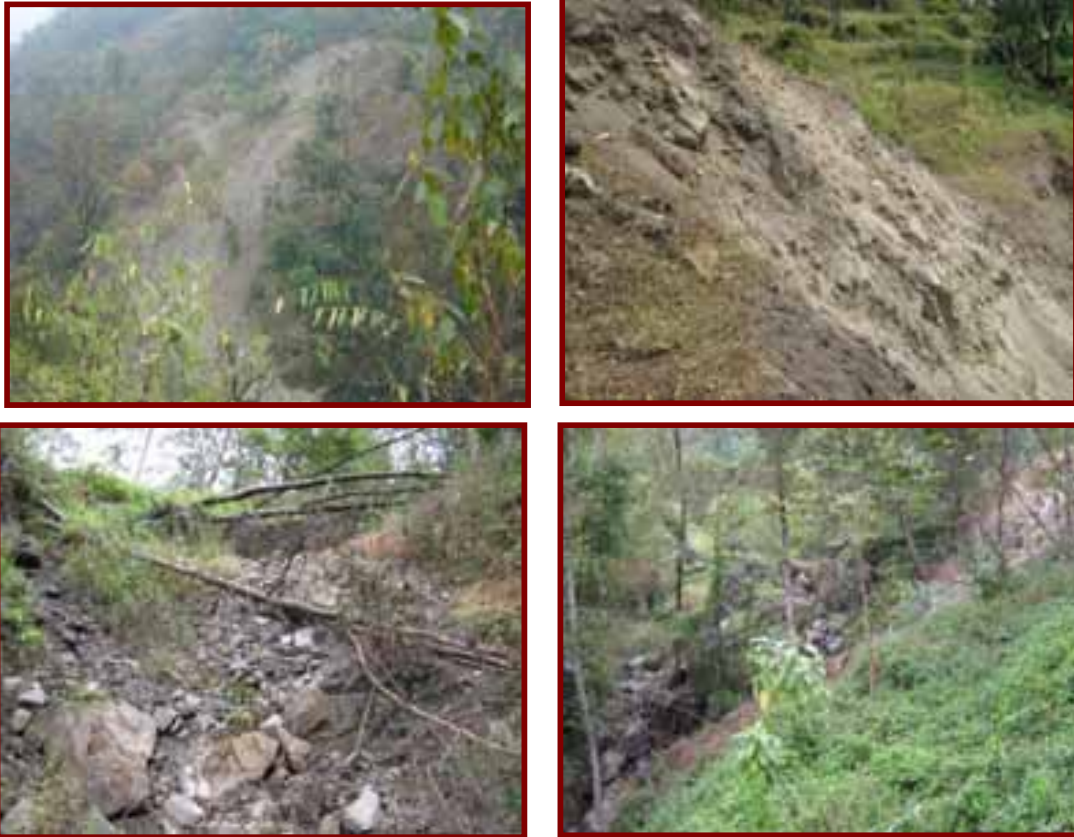
(The type of Landslide in the area and the same area under control)

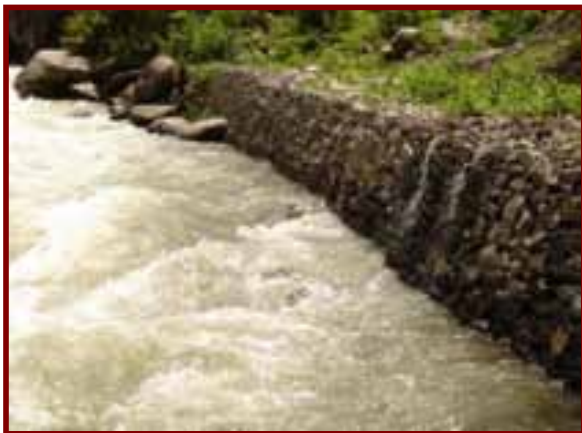
Jhora training works i.e. hand packed stone wall inside sausage have been built along the river beds to prevent the excess pressure on the banks of the river, further preventing the gush of water from eroding the soil mass and causing landslide. The works have enhanced the process of regeneration, soil binding thus reducing species stress and loose soil formation.

(River bank treatment reduces scouring action of river and strengthens bank)

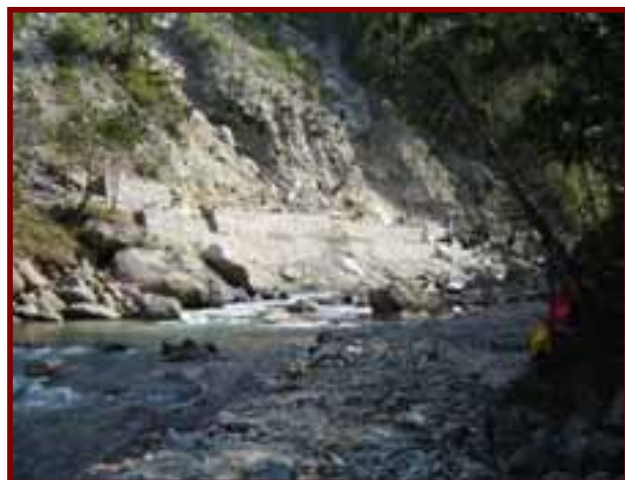
*(Control of toe erosion by engineering works
Supplemented with vegetation)*

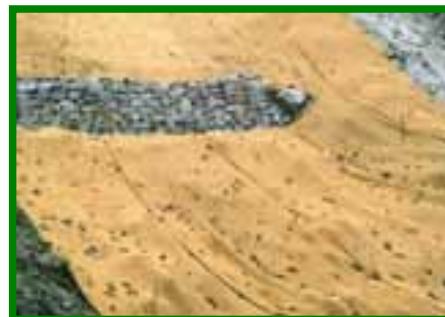
2. Coir mats made up off jute was laid down during rainy season to prevent erosion, in mulching process, soil binding process, further helping in the growth of certain herbs and shrubs. Mulch conserves moisture in soil, acts as an insulator. (Picture: Gentle slope with flying ash and moving soil checked with geo-textile technology supplemented with vegetation)

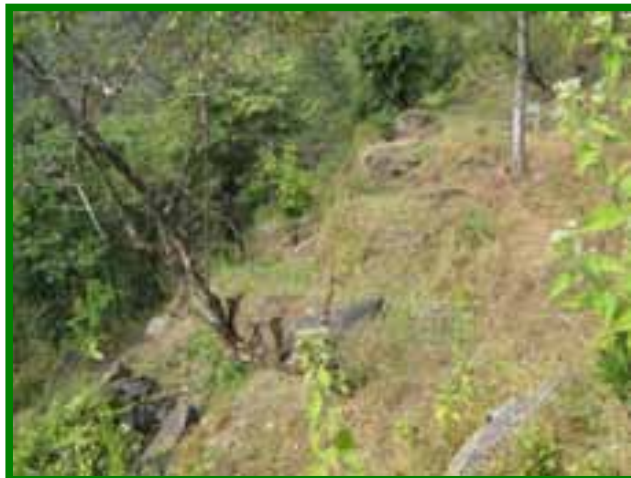
*Wet cultivation is one of landslide aggravation;
Treatment of the site cutting with sausage wall rendered protection*

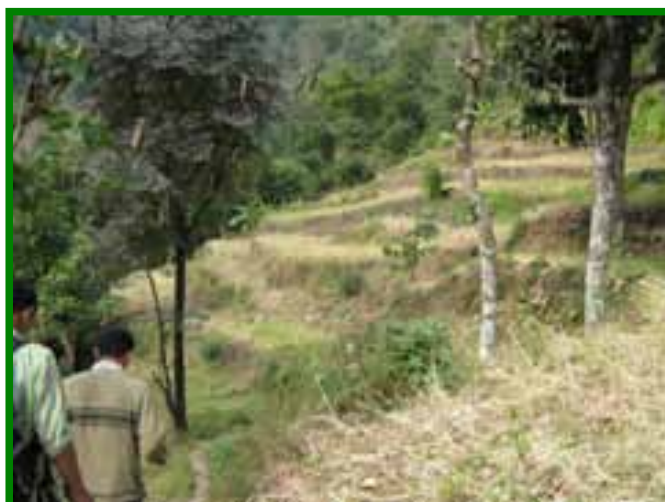
Degraded land brought under cultivation with contour bounds

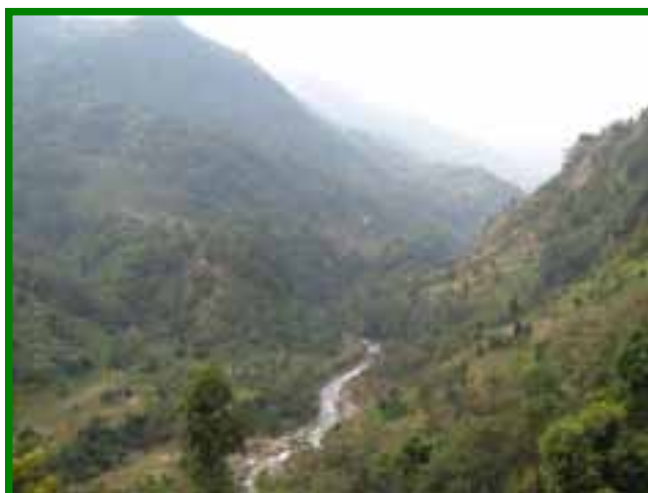
Kalej khola at the base of the slope, a major problem creator.

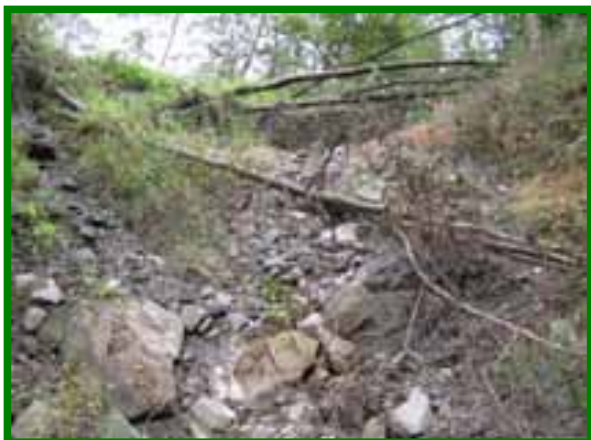
Movement of slush, boulders and soil checked with local dry stone wall

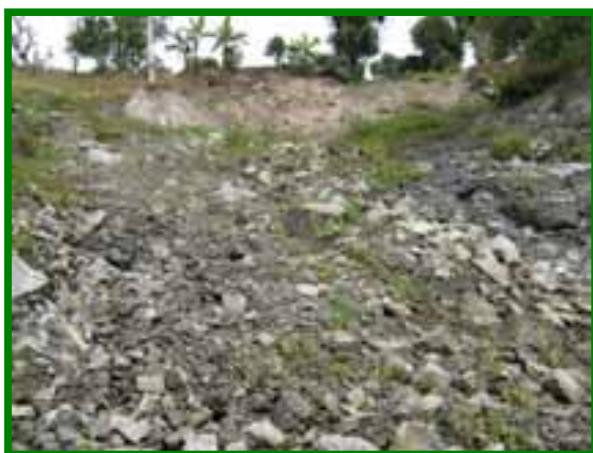
*Part of Agricultural land damage due to landslide and erosion-
A common feature.*

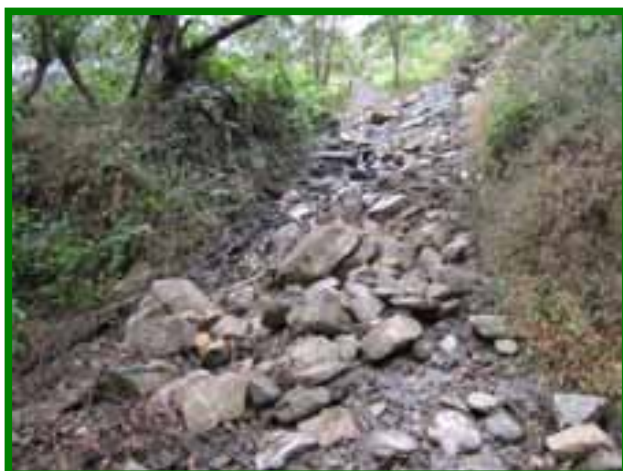
Part of Agricultural land damage and the formation of gullies

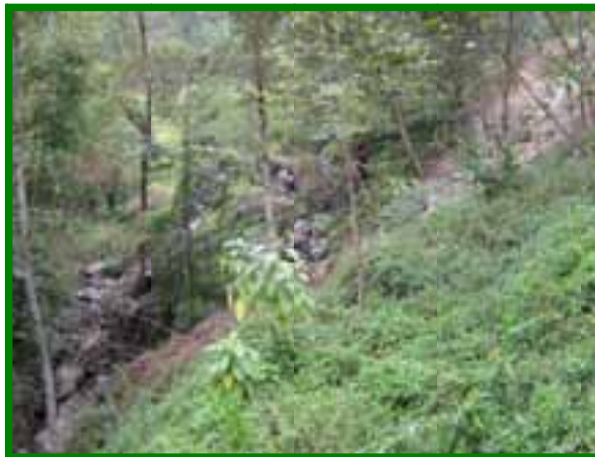
Landslide interspersed in between stable area

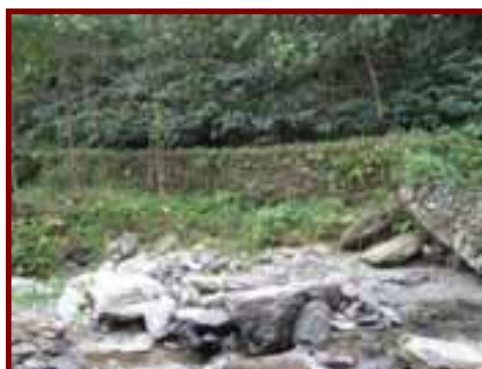
Protection of cardamom field with toe walls

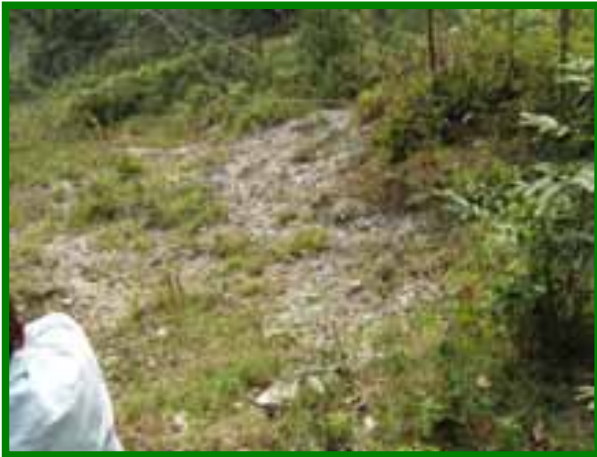
Type of debris flow

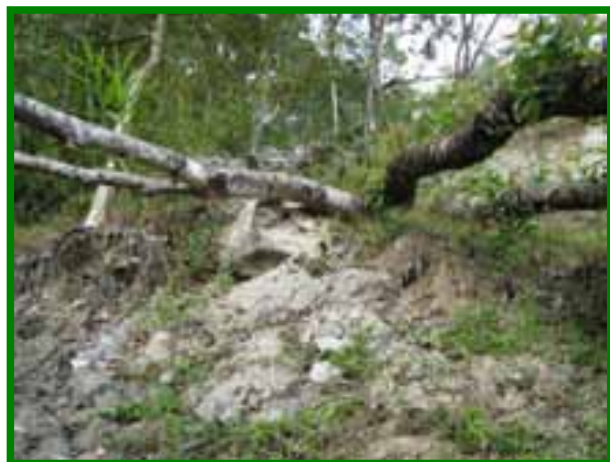
*Uprooting of tress by erosion and the retention of soil
by the blockage by the tree trunks.*

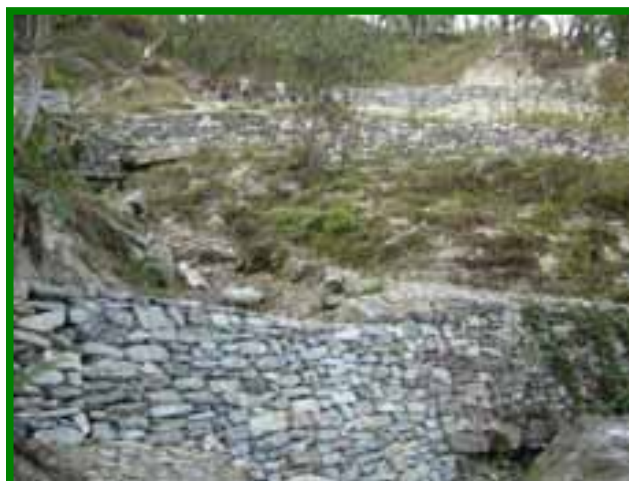
Engineering works supplemented with vegetation

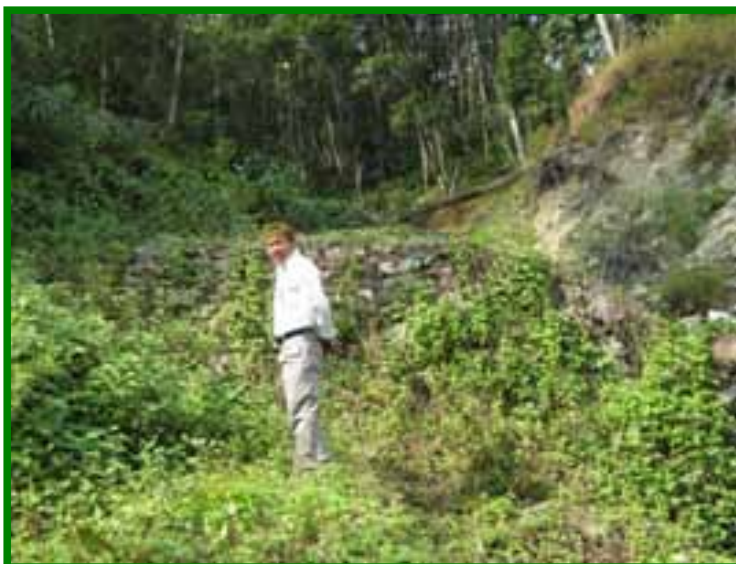
*Retention of the soil by hand packed stone wall
Inside G.I sausage, therefore profuse vegetation growth*

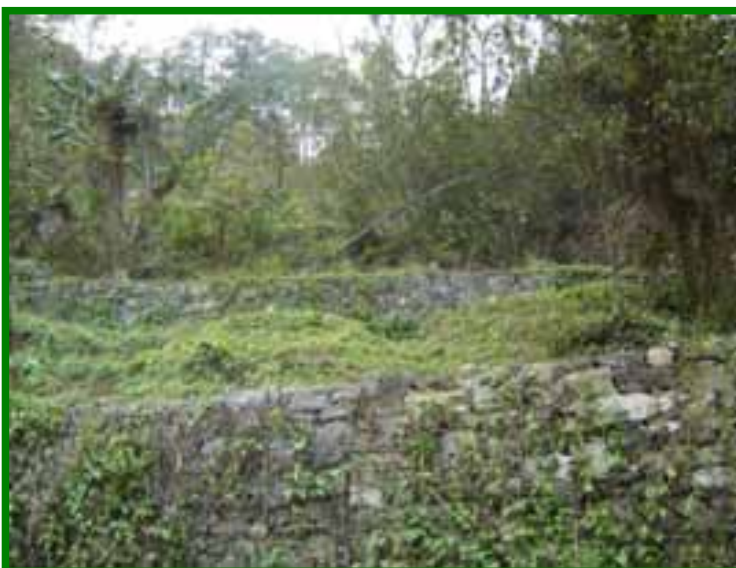
*Retention of the soil by hand packed stone wall
Inside G.I sausage, therefore profuse vegetation growth*
